The hazards of coastal erosion in Central Java, Indonesia: An overview

Abstract

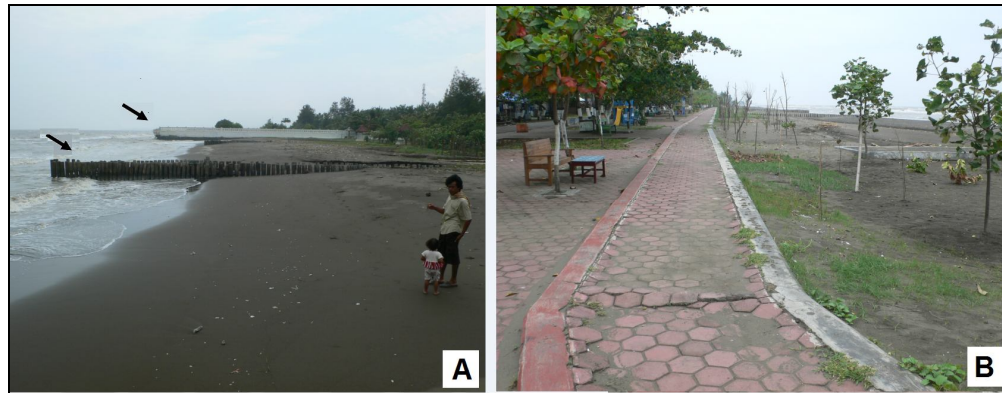
Figure 6. Structure measure/groin (A) and protected coastal area for tourism activity (B)

Coastal community in Tegal responded to the erosion problems by mangrove re-forestation and constructing structures such as ripraps, seawalls, jetties and groins. The groins, which the local government built in 2001, had been quite effective in reducing erosion at certain points along the coastline. They had also turned the area into a tourist attraction (Figure 6). Apart from that, forest (mangrove) rehabilitation would go a long way to reduce the erosion threat while producing food for the fish through the photosynthesis of organic matter.

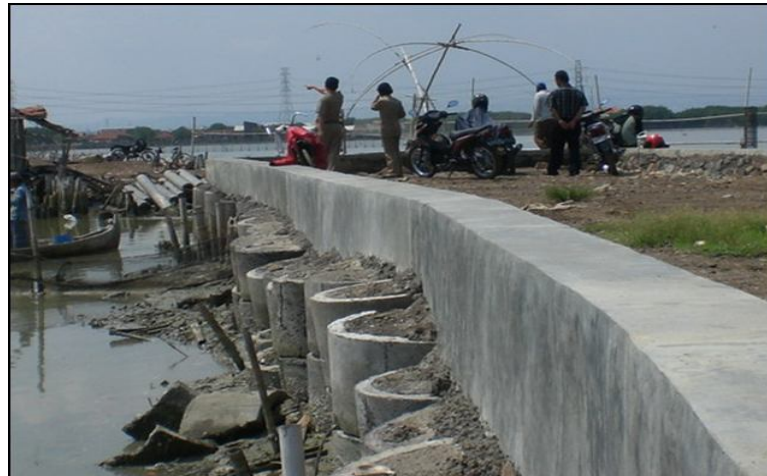
Figure 8. *Structural coastal defense in Demak*

Local government had strengthened the coordination among governmental agencies to cope with the issue of coastal erosion. Environment Affairs Office of Demak Regency (Kantor Lingkungan Hidup/KLH), Ministry of Marine Affairs and Fisheries Republic of Indonesia (Kementrian Kelautan dan Perikanan), and the Ministry of Agriculture Republic of Indonesia (Kementrian Pertanian) are involve on the coastal mitigation action against erosion process. Local government had also built the dike along the coastal area to block the tide and wave action (Figure 8).
